THE ROTUNDA

APPENDIX D

UNIVERSITY OF VIRGINIA  
ROTUNDA

MEP/FP FINDINGS  
&  
RECOMMENDATIONS  
Feb 12<sup>th</sup> 2007

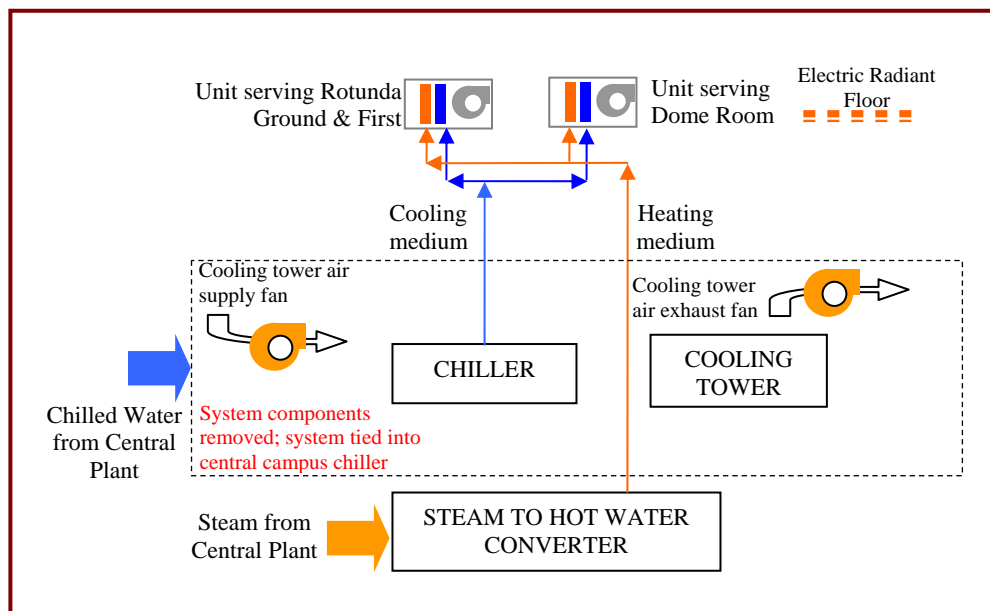
The 1974 HVAC system configuration and later modifications are illustrated below.

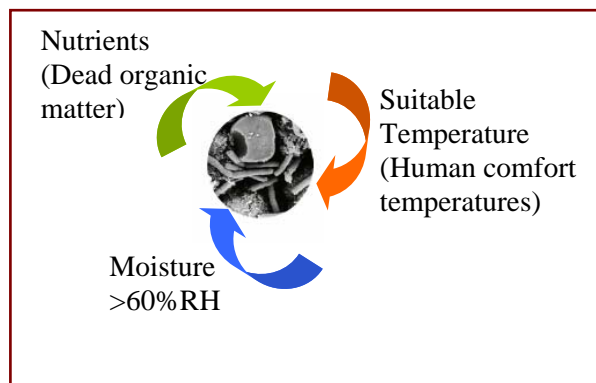
The following analysis is not a result of exhaustive research and testing. It attempts to outline the potential factors contributing to the mold problem based on a review of existing conditions and existing HVAC system design and operation.

contact with cold surfaces (cold air from perimeter dome supply) it can cause condensation, promoting conditions for mold growth.
